**REMOVAL SUMMARY REPORT
FOR THE
NORWOOD INDUSTRIES FUND LEAD REMOVAL
TOLEDO, LUCAS COUNTY, OHIO**

Date Prepared	January 29, 2010
TDD Number	S05-0001-0809-014
Document Control Number	533-2A-AEYC
Site Specific ID Number	B5PA
Contract Number	EP-S5-06-04
WESTON START Project Manager	TJ McFarland
Telephone No.	(440) 202-2805
U.S. EPA On-Scene Coordinator	Jon Gulch

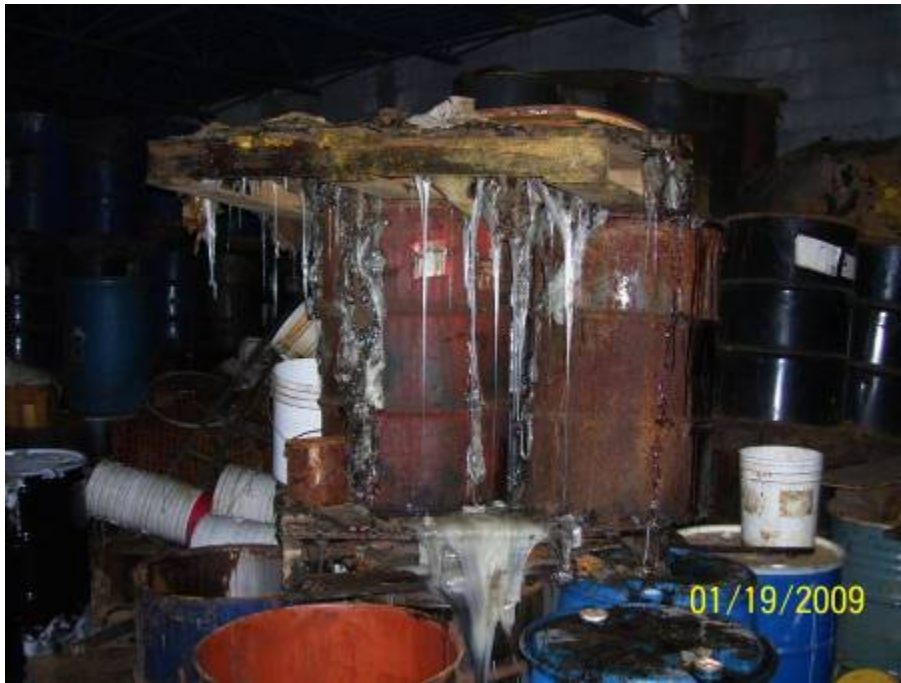
Photograph No.: 1

Subject: Uncontained Paracril “experiments” in Room 1 of warehouse building

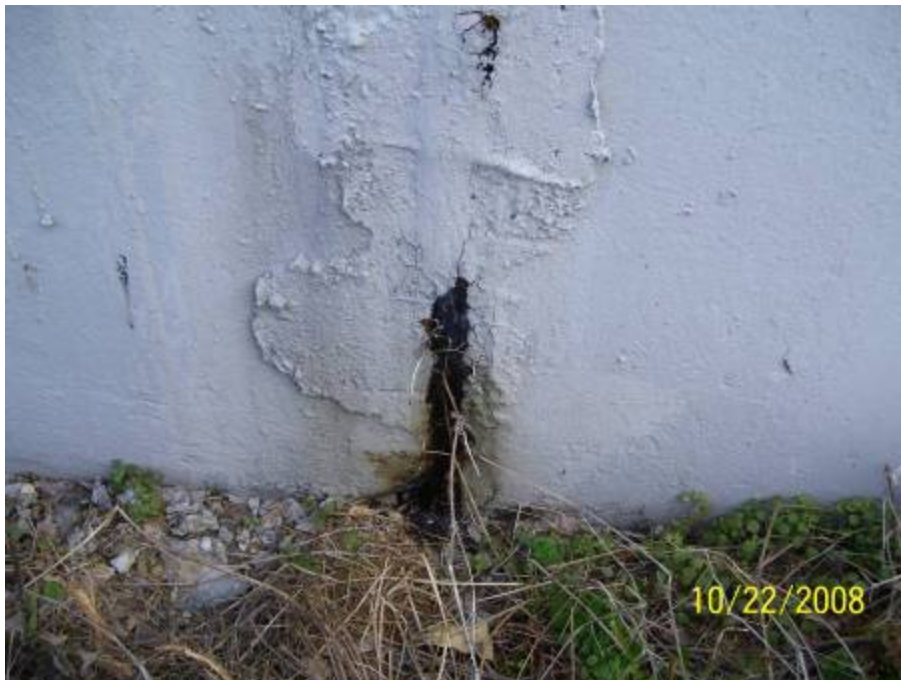
Photograph No.: 2

Subject: Paracril leaking through the western foundation wall of the warehouse building

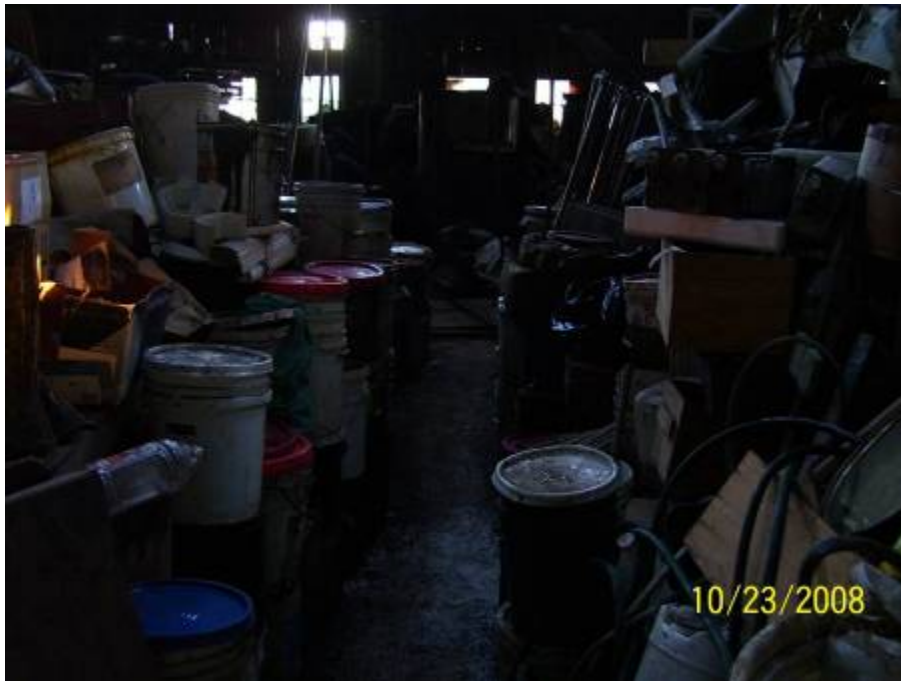
Photograph No.: 3

Subject: Warehouse “aisle” before general debris removal

During the removal site assessment, approximately 80 percent of the warehouse building was inaccessible due to a large amount of bulk debris. The building basement was also inaccessible during the site assessment. From October 21, 2008, through March 3, 2009, ERRS contractors cleared out the interior of the warehouse building by removing and disposing of non-hazardous

bulk debris and temporarily removing large pieces of equipment and debris. Removed equipment and debris were staged in the fenced courtyard area east of the warehouse building (see Figure 3). These activities were required to allow safe access to portions of the building that contained extensive amounts of general debris intermingled with waste containers. A total of 25 20-cubic yard (yd³) roll-off boxes of bulk debris were transported off-site for disposal as non-hazardous waste.

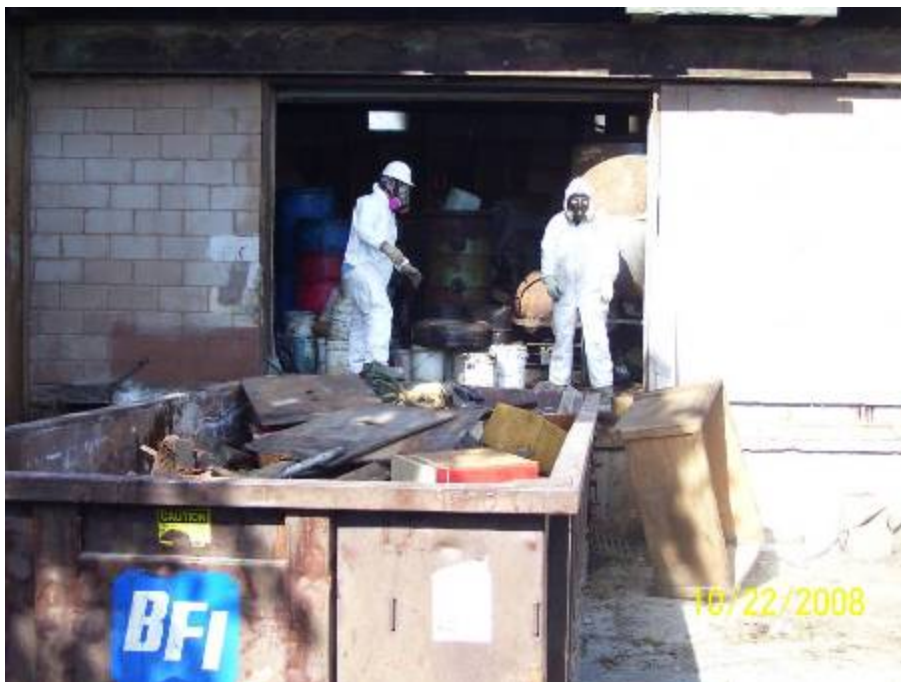
Photograph No.: 4

Subject: ERRS crew disposing of non-hazardous construction and demolition debris in Level C PPE

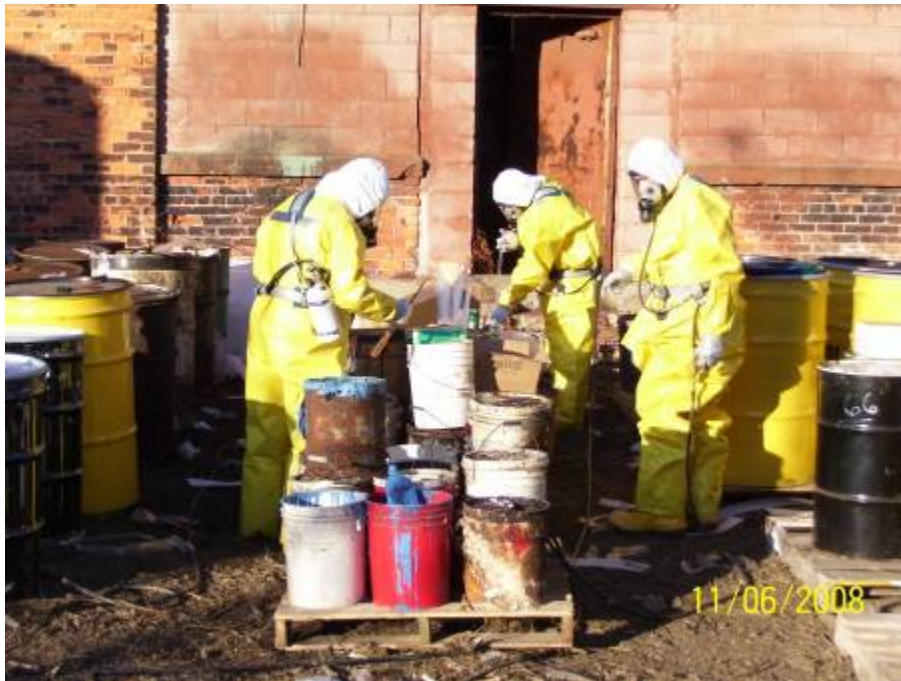
Photograph No.: 5

Subject: ERRS crew sampling 5-gallon containers in Level B PPE

Once initial waste container staging and segregation activities were completed, the ERRS contractor began sampling materials from the various containers. Sampling was conducted in an established hot zone. The sampling crews used supplied air and Level B personal protective equipment (PPE). A drum sampling log was completed for each drum, pail, and container. WESTON START provided continuous perimeter, hot zone, and supplemental air monitoring during sampling activities (see Section 5.0).

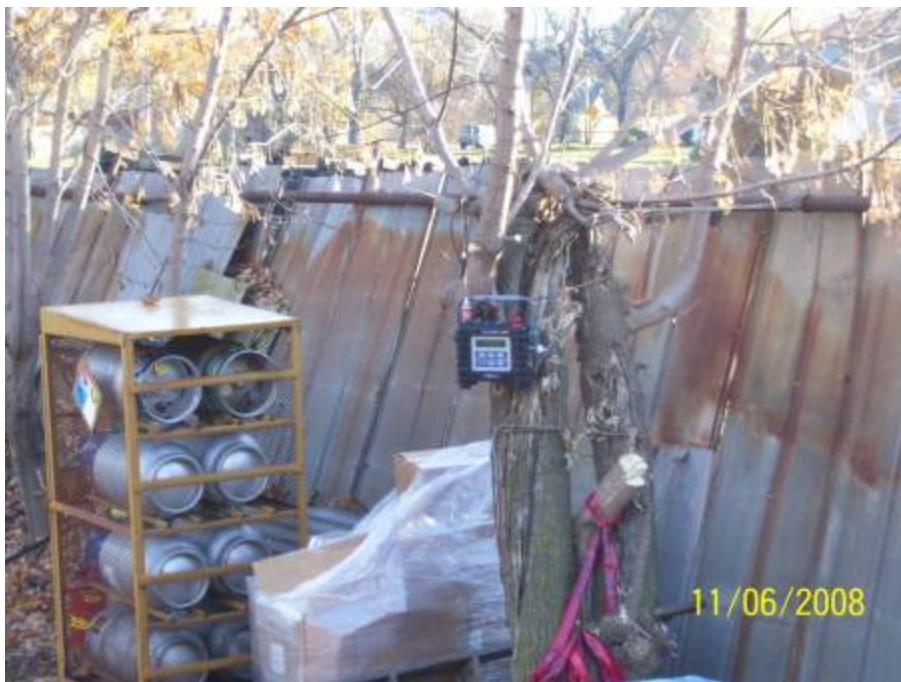
Photograph No.: 6

Subject: AreaRAE perimeter air monitoring location

During on-site removal action activities, WESTON START performed continuous hot zone, perimeter, and supplemental/periodic air monitoring throughout the Site. Air monitoring was conducted at three rotating stations within the warehouse building and one rotating station at the Site perimeter during all removal activities. WESTON START used the RAE Systems, Inc., AreaRAE network to conduct real-time monitoring for total VOCs, percent of the lower explosive limit (%LEL), carbon monoxide, and percent oxygen. WESTON START also conducted real-time monitoring for particulates using a DataRAM and the U.S. EPA's Rapid Assessment Tools (RAT) software during all removal action activities. Additionally, WESTON START conducted periodic monitoring for total VOCs, %LEL, carbon monoxide, and percent oxygen in and around the Site hot zone and between the continuous monitoring stations in the warehouse building using a RAE Systems, Inc., MultiRAE. When air monitoring readings exceeded the site-specific health and safety plan (HASP) action levels during removal action activities, corrective actions were taken and PPE was modified as specified in the HASP.

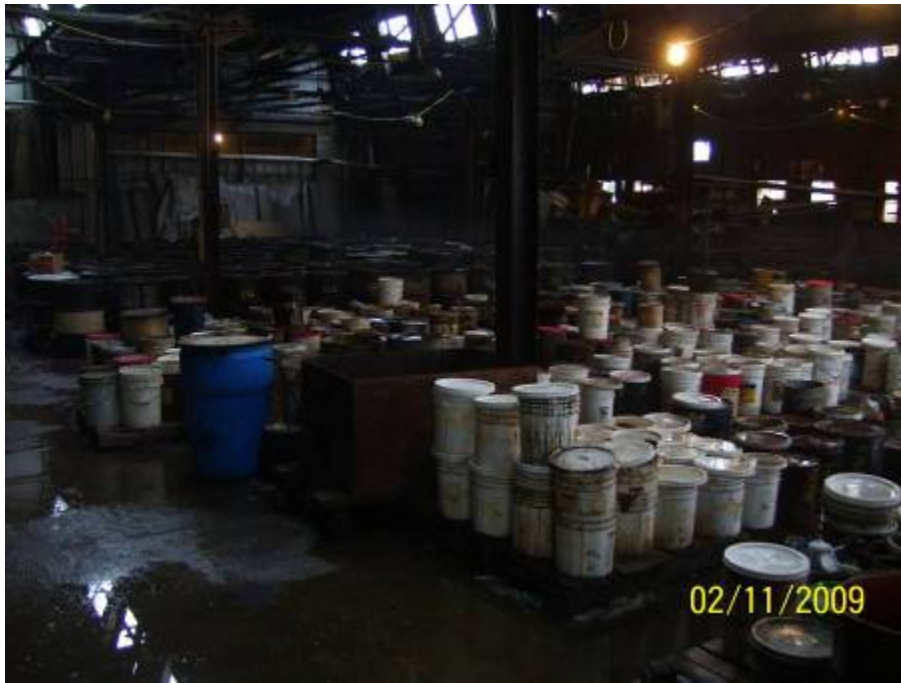
Photograph No.: 5

Subject: Central portion of the warehouse building used to inventory and sample drums and containers

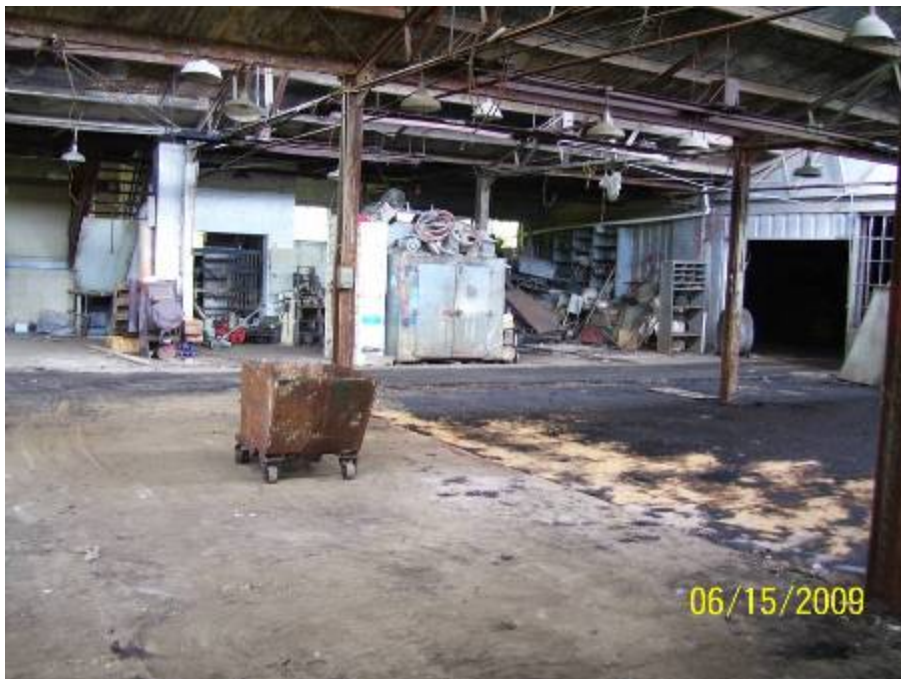
Photograph No.: 6

Subject: Central portion of warehouse building after the removal of hazardous materials

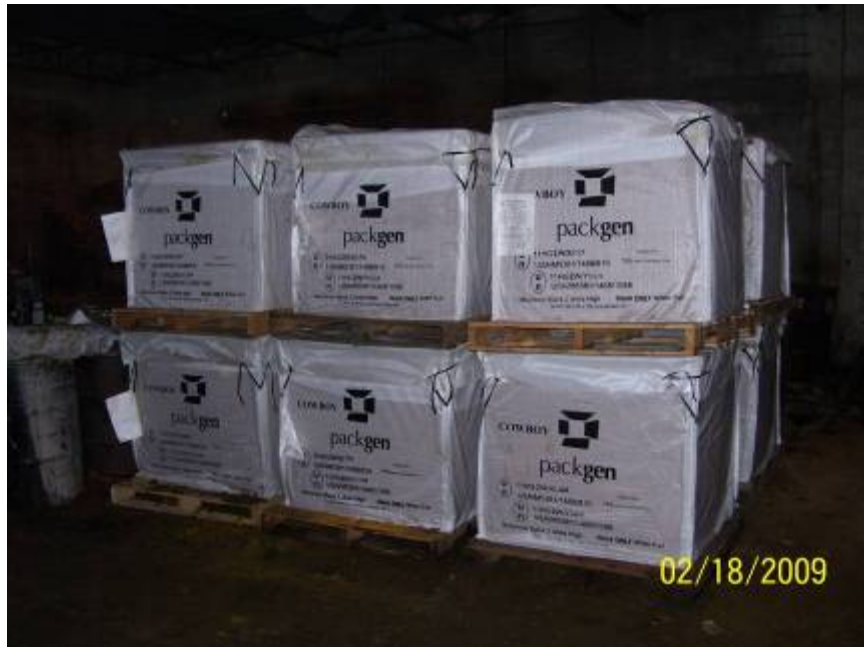
Photograph No.: 7

Subject: 1-yd³ boxes containing floor sweepings and Paracril debris pending disposal

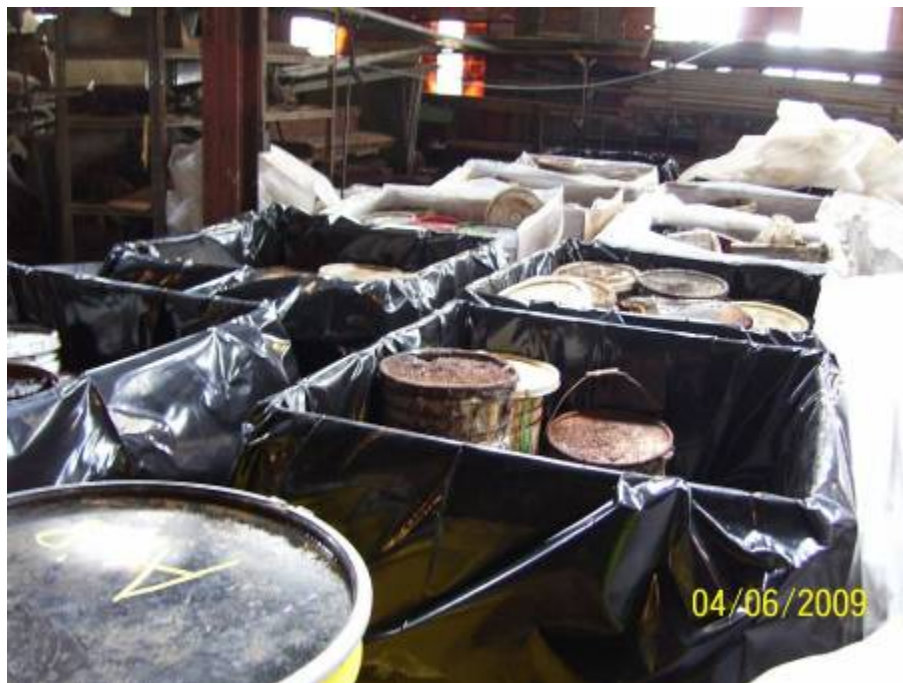
Photograph No.: 8

Subject: Compatible solids bulked into lined 1-yd³ boxes

Once the waste streams were defined, the ERRS crew consolidated the wastes into disposal categories. Compatible wastes were bulked to eliminate partially full and deteriorated containers. RCRA-empty poly and metal drums from the bulking activities were crushed and placed in a roll-off box prior to disposal as non-hazardous waste.

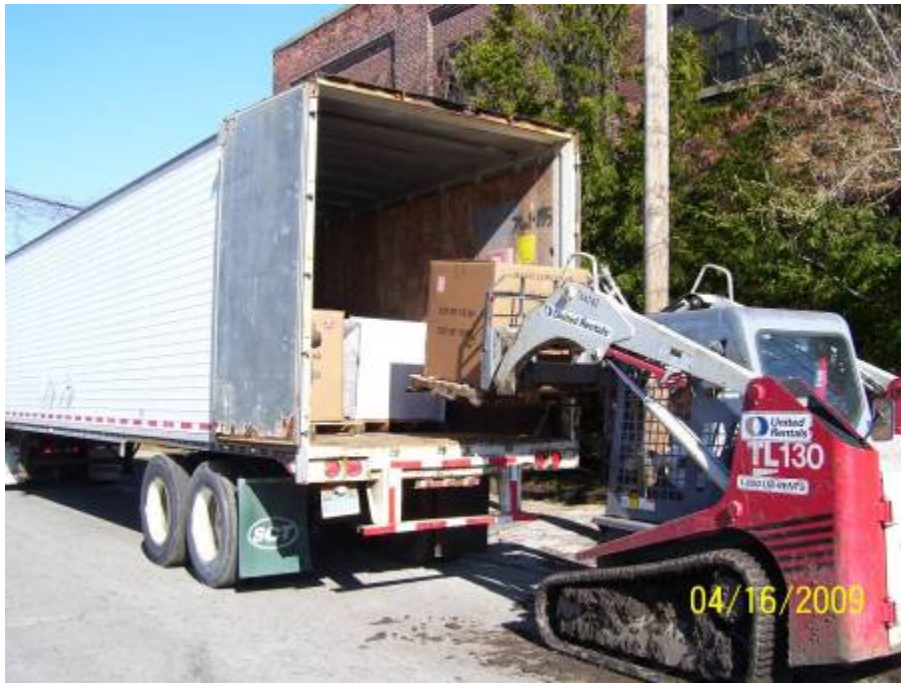
Photograph No.: 9

Subject: ERRS crew loading a semi-trailer with 1-yd³ boxes for disposal

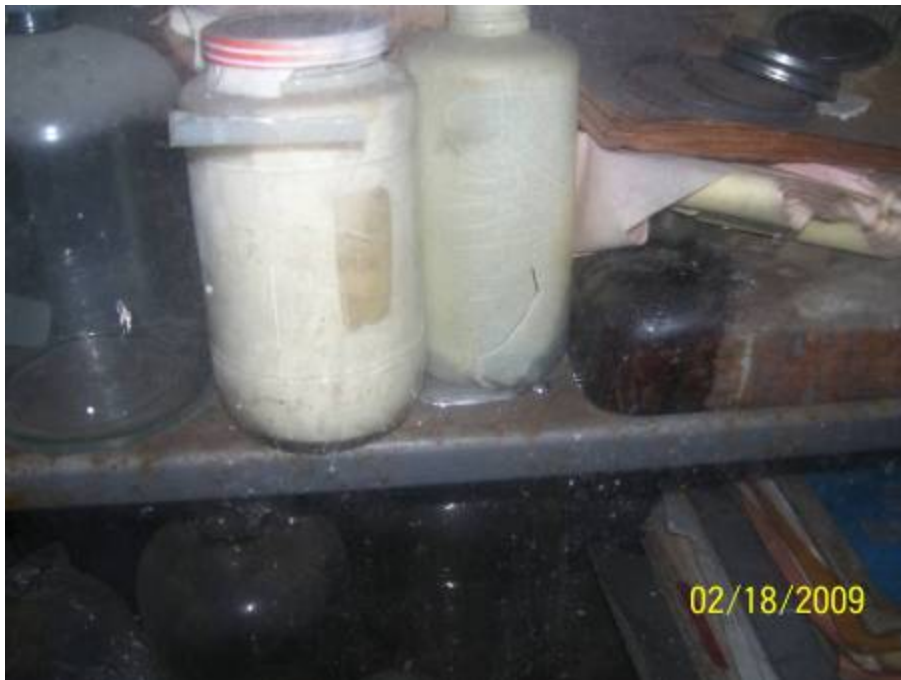
Photograph No.: 10

On February 17, 2009, ERRS personnel identified uncontained mercury in an upstairs, three-shelf laboratory cabinet in the warehouse building. U.S. EPA mobilized a Lumex RA 915+ mercury analyzer (Lumex) to the Site to confirm that the uncontained mercury was confined to the laboratory cabinet and that the surrounding area had not been contaminated. Before the mercury removal, WESTON START conducted initial screenings using the Lumex. Mercury

vapor readings ranged from 15,000 to 50,000 micrograms per cubic meter ($\mu\text{g}/\text{m}^3$) within the breathing zone level in front of the laboratory cabinet. Readings from the wood floor in front of the cabinet ranged from 12,000 to 15,000 $\mu\text{g}/\text{m}^3$.

Subject: Uncontained elemental mercury in laboratory cabinet

On February 24, 2009, the ERRS contractor removed the uncontained mercury using pipettes, HgX® powder and a mercury vacuum. Miscellaneous debris around the laboratory cabinet was placed into bags and sealed. Glassware from inside the cabinet also was bagged and sealed for later screening. After the mercury was removed, HgX® powder was applied within the cabinet and on the surrounding floor area. Post-removal mercury readings inside the laboratory cabinet ranged from 1,500 to 4,600 $\mu\text{g}/\text{m}^3$. The ERRS contractor conducted a second round of mercury removal activities using a mercury vacuum to remove remaining “micro” mercury beads and completed another application of HgX® powder. After the second round of mercury removal activities, mercury readings in the cabinet ranged from 500 to 2,000 $\mu\text{g}/\text{m}^3$. The laboratory cabinet then was wrapped in polyvinyl sheeting for disposal at an U.S. EPA-approved disposal facility along with small debris from within and in front of the cabinet. Post-removal mercury vapor readings at the floor level around the cabinet averaged around 500 $\mu\text{g}/\text{m}^3$.

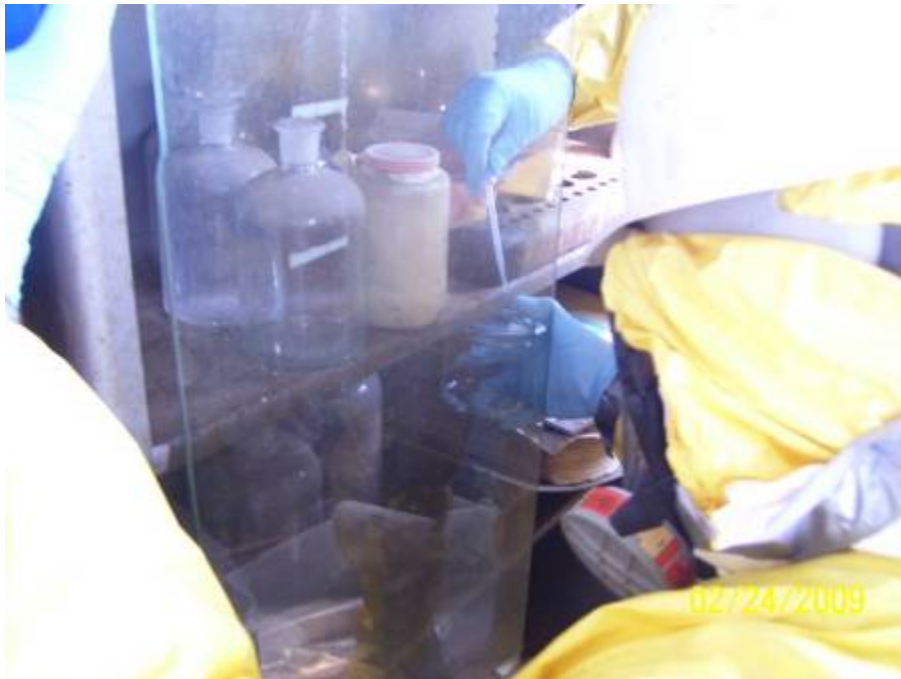
Photograph No.: 11

Subject: ERRS crew removing uncontained elemental mercury using pipettes

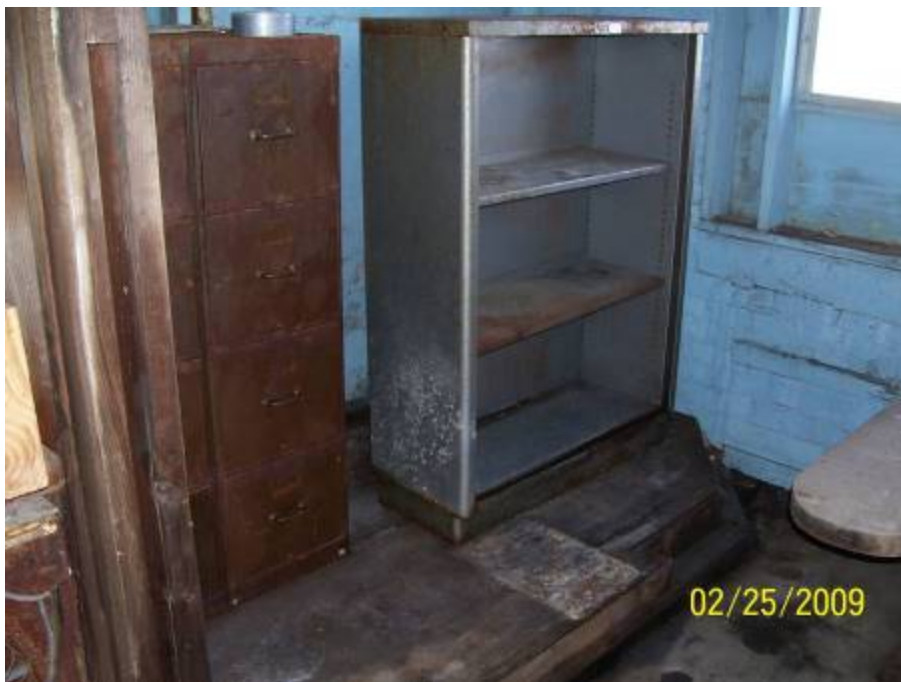
Photograph No.: 12

Subject: Laboratory cabinet and surrounding area after mercury removal activities

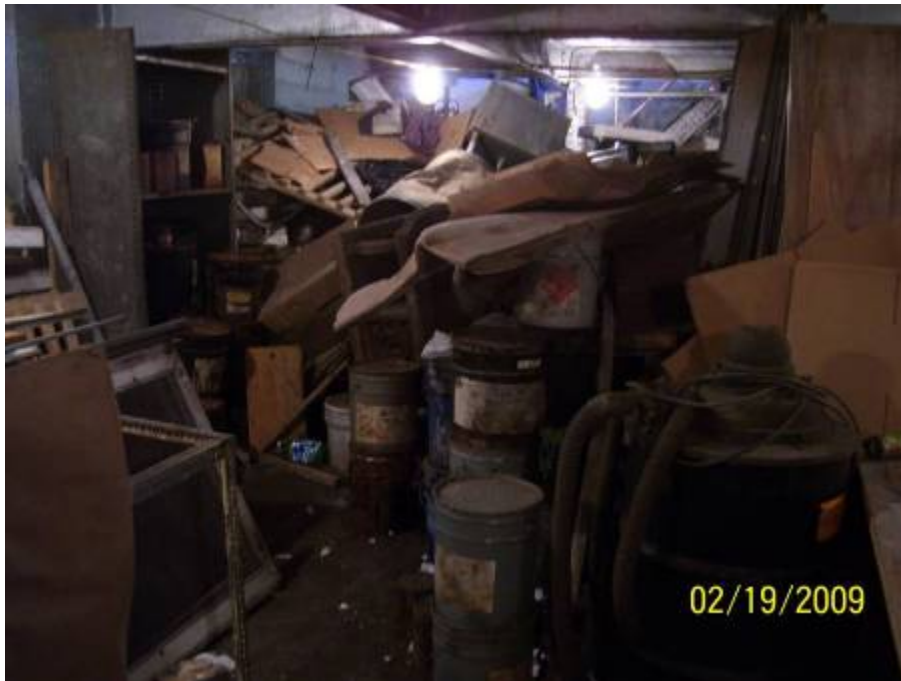
Photograph No.: 13

On November 18, 2008, U.S. EPA, the ERRS contractor, and WESTON START inspected the basement of the warehouse building, which was previously inaccessible due to the haphazard placement of general debris. Several hundred additional small containers were discovered throughout stockpiled debris in the basement.

Subject: Eastern portion of the basement before removal activities

From March 4 through April 17, 2009, U.S. EPA and its contractors searched through the general debris in the basement. A “pulley-sled” system was constructed on the basement stairs to relay materials efficiently to the first floor of the warehouse building. As discussed in Section 4.1, a total of 350 tons of non-hazardous construction and demolition debris was removed from the building. This waste was transported to Vienna Junction Landfill in Erie, Michigan, for disposal.

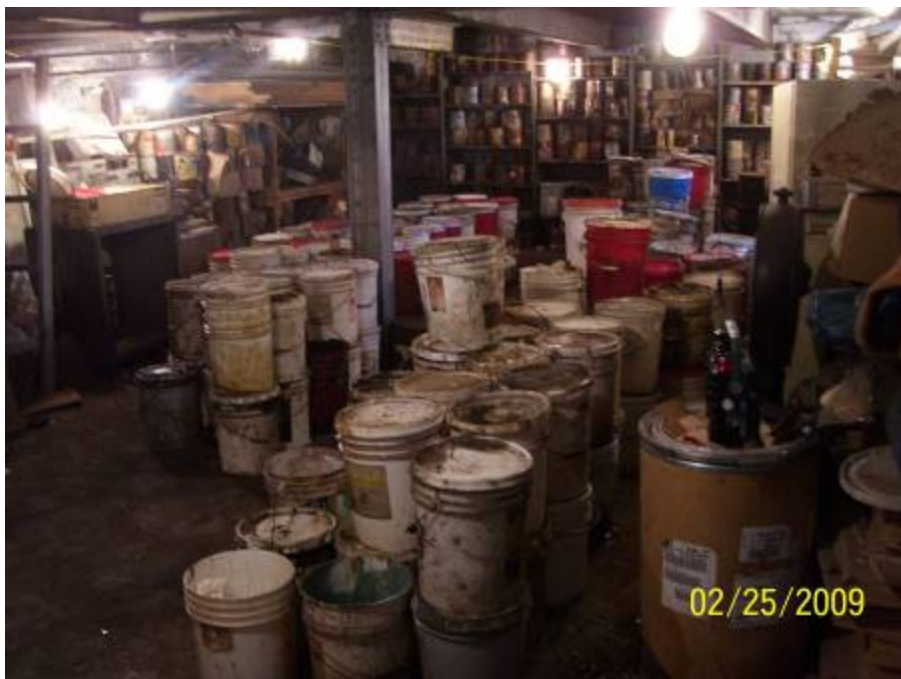
Photograph No.: 14

Subject: Eastern portion of the basement used for staging and sampling containers

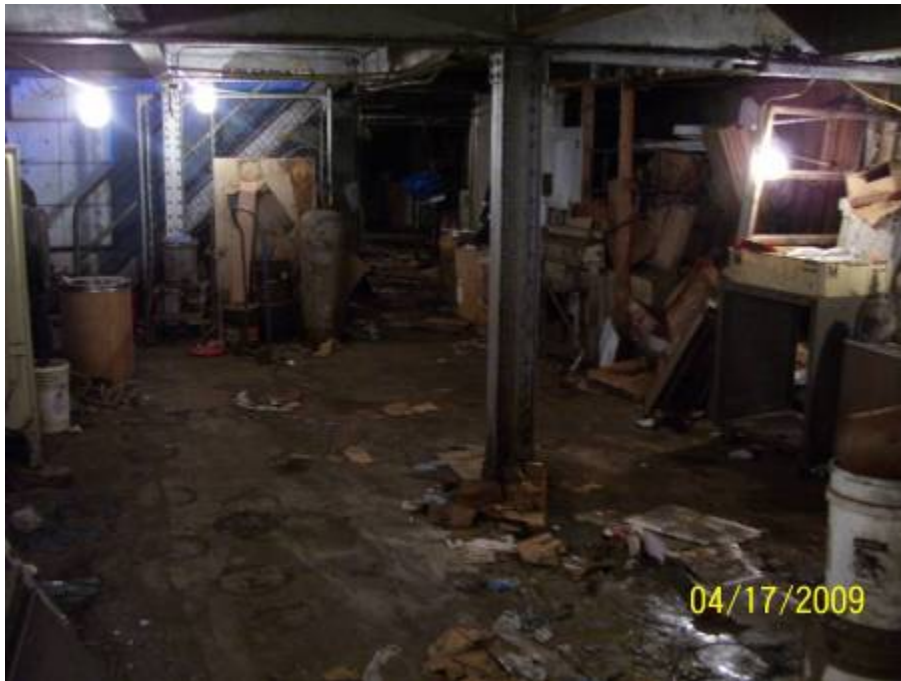
Photograph No.: 15

Subject: Eastern portion of the basement after hazardous materials removal activities
